Response of a Structure
to an Explosive-Generated Ground Shock

by
D. E. Hudson, J. L. Alford, and
G. W. Housner

September 1952

THIRD TECHNICAL REPORT

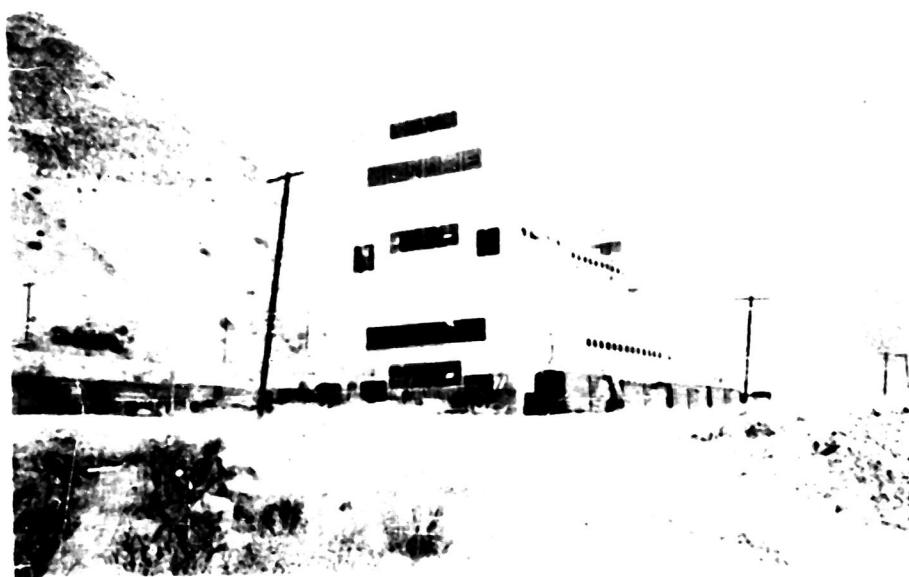
Figure 3. Looking west at steel-frame mill building. Explosion occurred at face of hill just left of upper part of building.

The building in which the measurements were made is a steel-frame mill building constructed in 1947. It has corrugated iron siding and roofing and its plan dimensions are 65 feet by 285 feet. A photograph of the building is shown in Figure 3, looking west. The face of the hill where the explosives were detonated is visible just to the left of the building. The east end of the building is taller than the west end which is a typical one-story mill building. Details of the framing of the one-story portion are shown in Figure 4. The east end of the building has plan dimensions of 65 feet by 37 feet. The overall height of this portion of the building is 103 feet above the ground floor. At an elevation of 45' - 8" above the ground floor there is a 6" thick concrete floor slab (65' x 37'). This floor slab is at approximately the same elevation as the roof of the one-story portion so that the heaviest mass of the building is concentrated at this elevation. Above this floor slab there is the steel wall and roof framing, the corrugated iron siding and roofing, and a steel deck floor at an elevation 84' - 6" above the ground floor. The framing of the east wall is shown in Figure 5. The ground floor of the building is an 8" reinforced concrete slab. There is a single basement beneath the one-story portion of the building and a double basement beneath the east end of the building, with 18" thick reinforced concrete walls. The sub-surface structure of the building thus is essentially a concrete box upon which the steel frame building is standing. A plan of the building is shown in Figure 6.

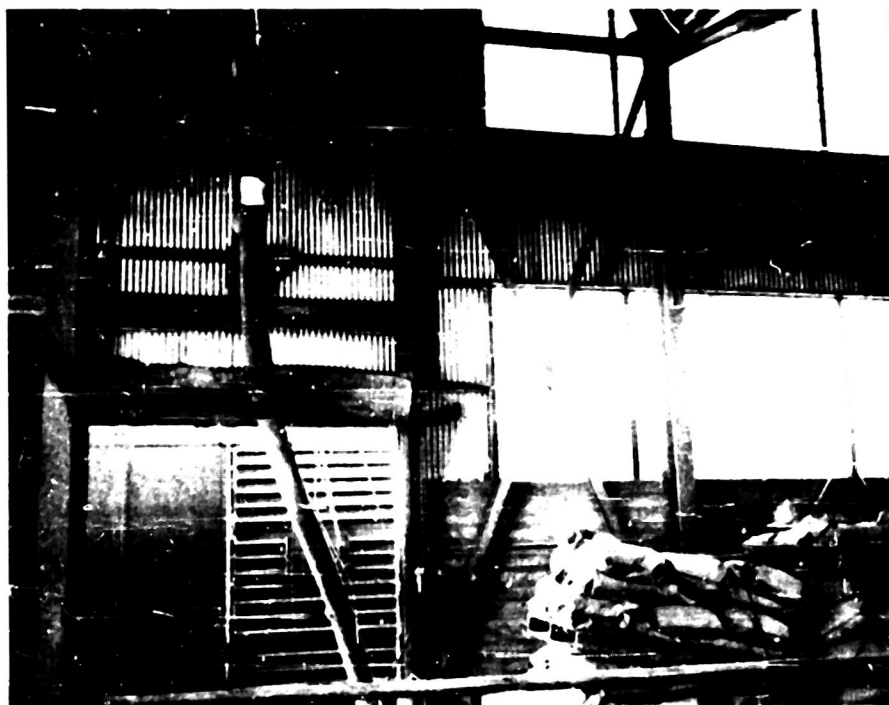
Figure 5b. South wall of mill building.

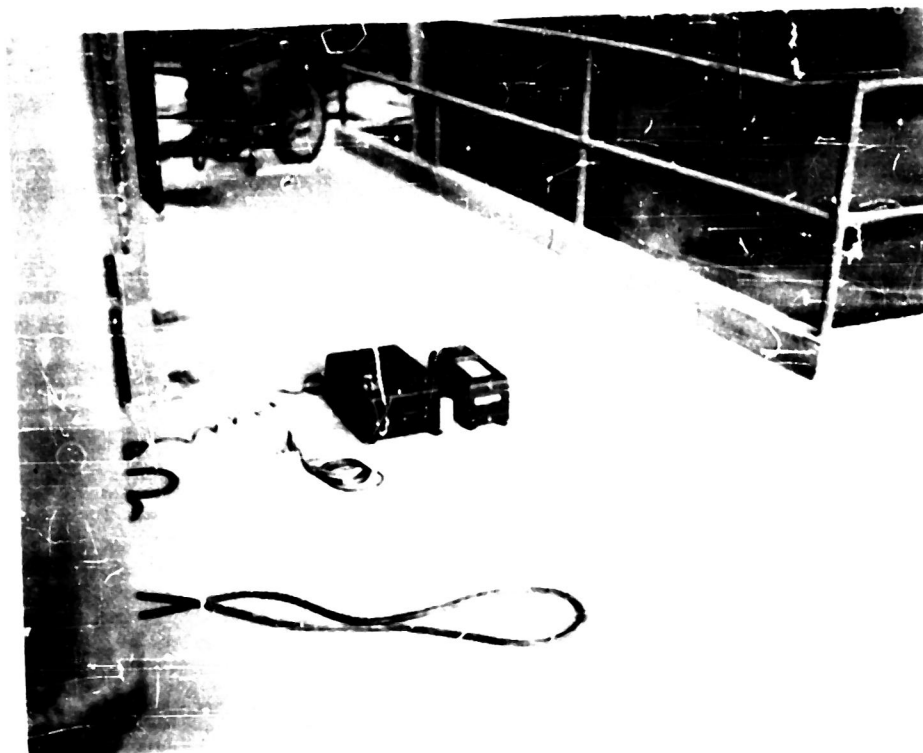
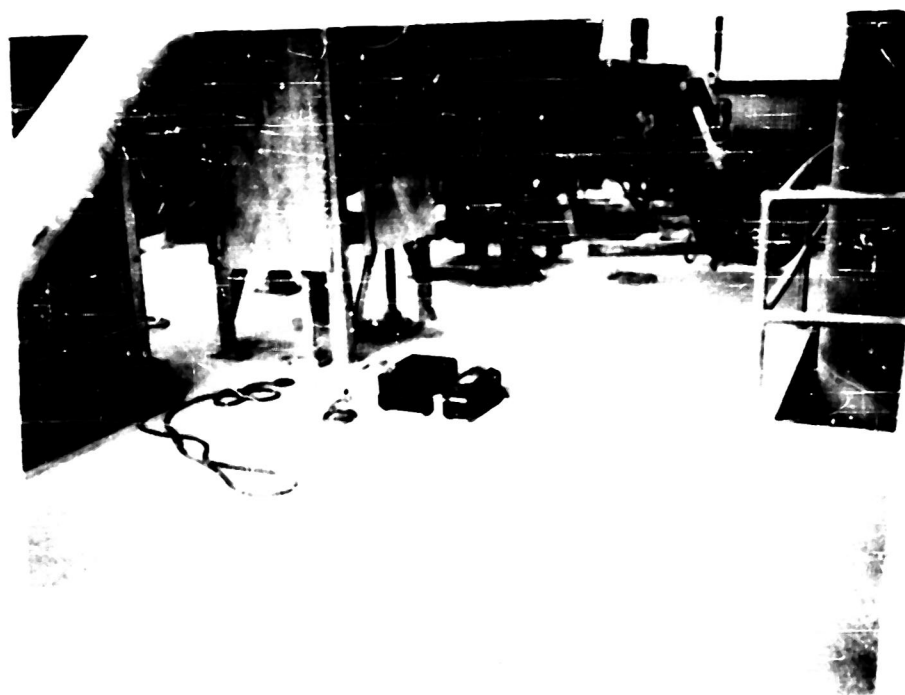
Figure 9a. Location of instruments on upper floor.

Figure 9b. Location of instruments on upper floor.

On the upper floor the instruments were located 25 feet from the north wall and 24 feet from the east wall. The accelerometer pick-up was bolted to the concrete slab by means of a small angle and the accelerometer was oriented so as to pick up motion in an east-west direction. The accelerometer was a William Miller Corporation Type 402-C, Serial No. 5. This instrument is a small seismic type accelerometer with a natural frequency of approximately 80 cycles per second. It has fluid damping (60% of critical) and a variable reluctance balanced-armature type measuring element. The overall size of the accelerometer is $1 \times 1 \frac{1}{2} \times 2 \frac{1}{2}$ in.

The output of the oscillator-amplifier was fed into a Brush Development Company, Type BL-202, Direct Inking Oscillograph, Serial No. 3027. The Amplifier-Oscillograph combination has a flat frequency response from 0 to 100 cycles per second. A photograph of this instrumental set-up is shown in Figure 9.
